# **STABILIZATION AND UPGRADING OLD TRANSPORTATION TUNNELS**

**by  
Rich Humphries and Mark Sandfort**

**Golder Associates**

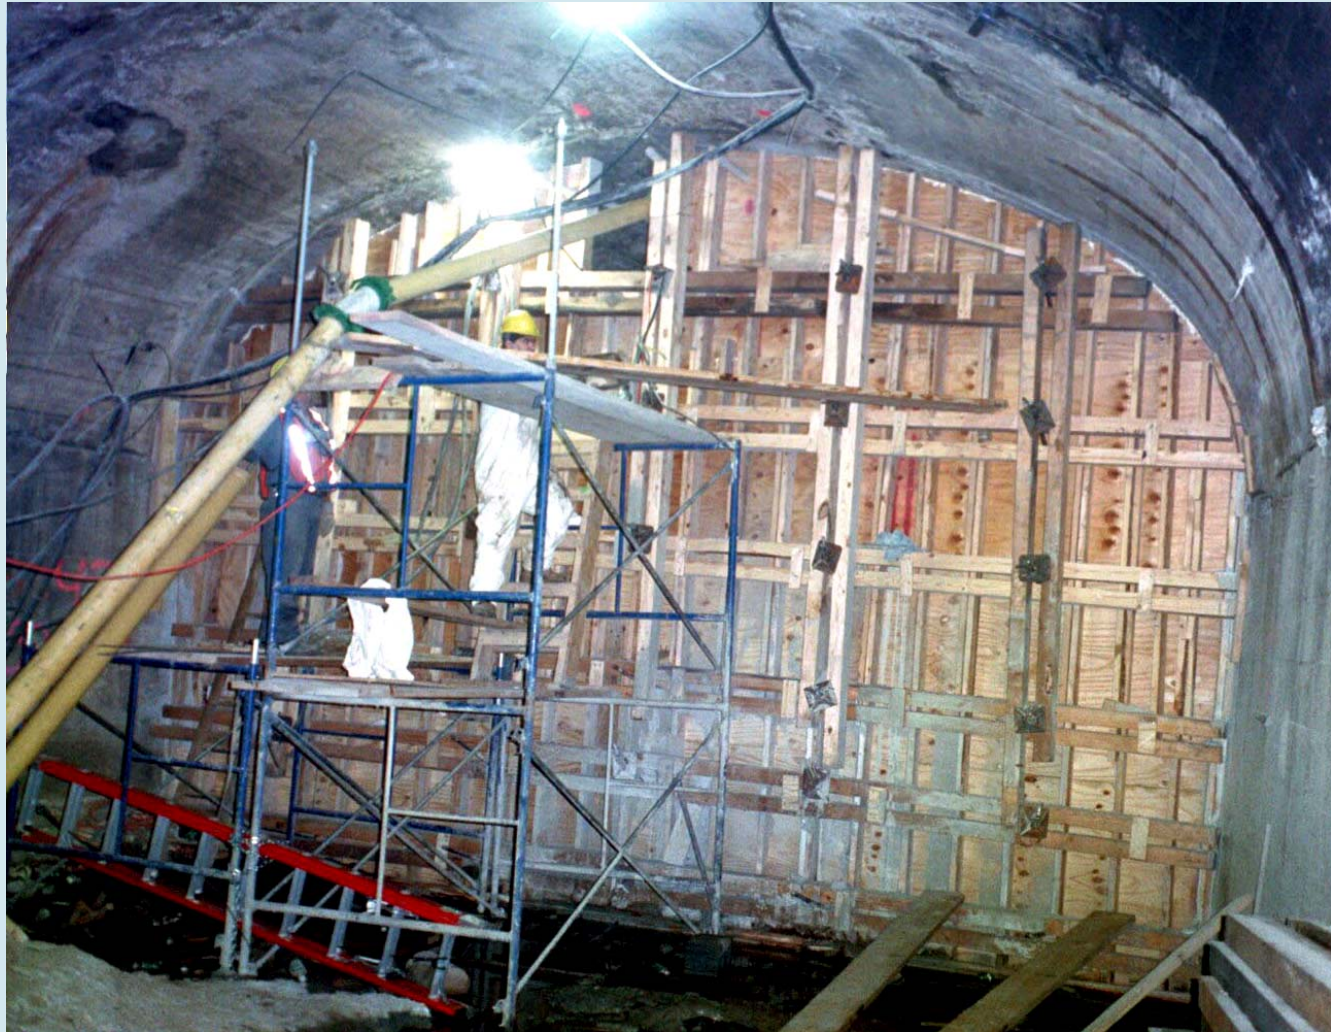
# Tunnel Plugs

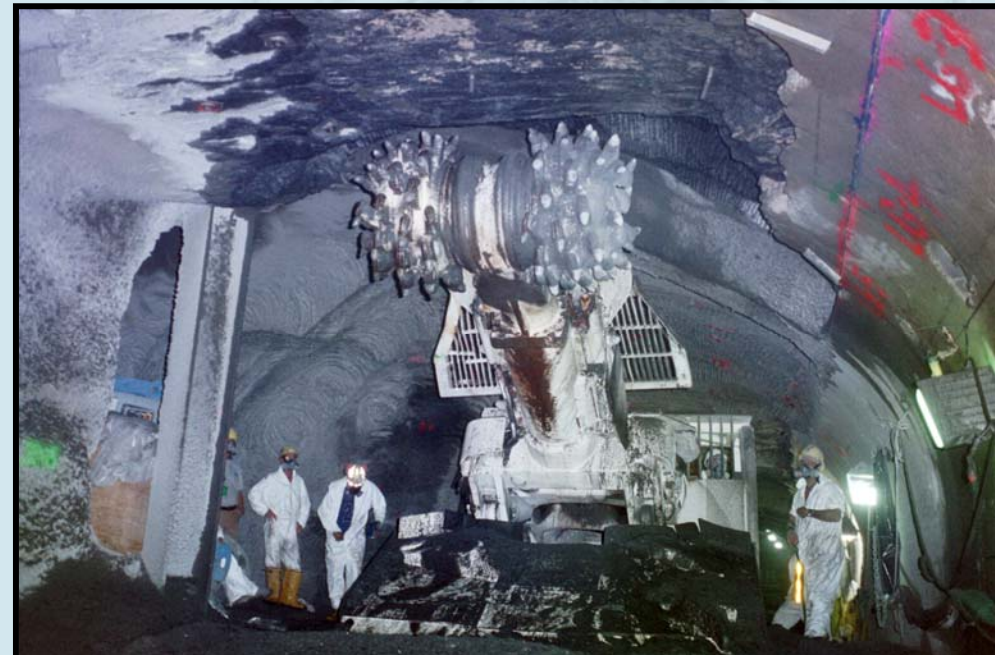
# Road-Header Excavation

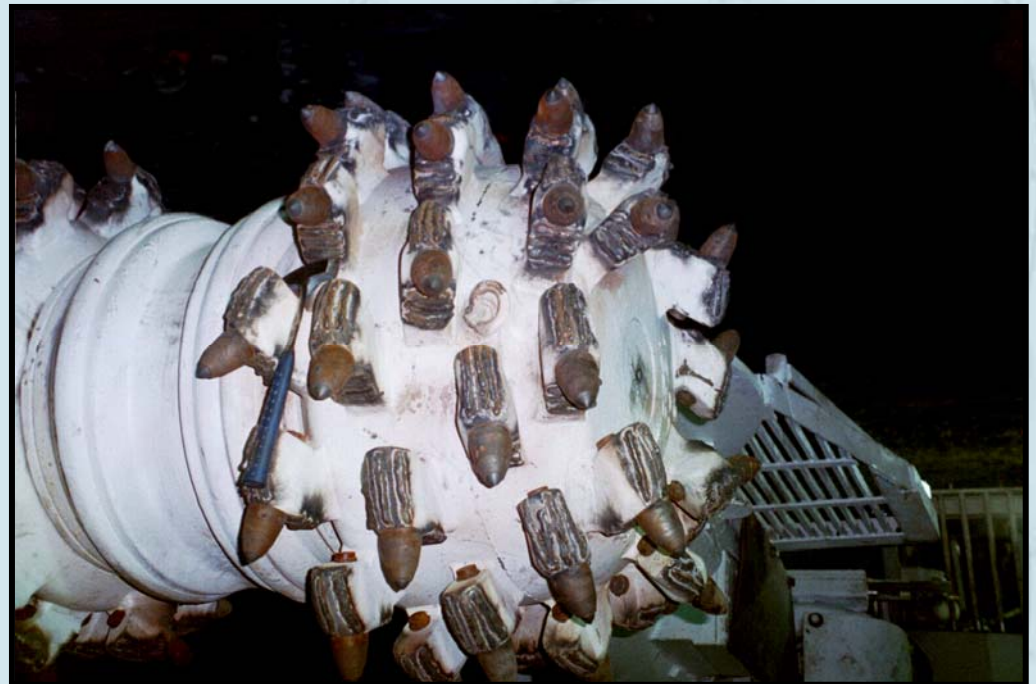
## Road-Header Excavation (Cont'd)

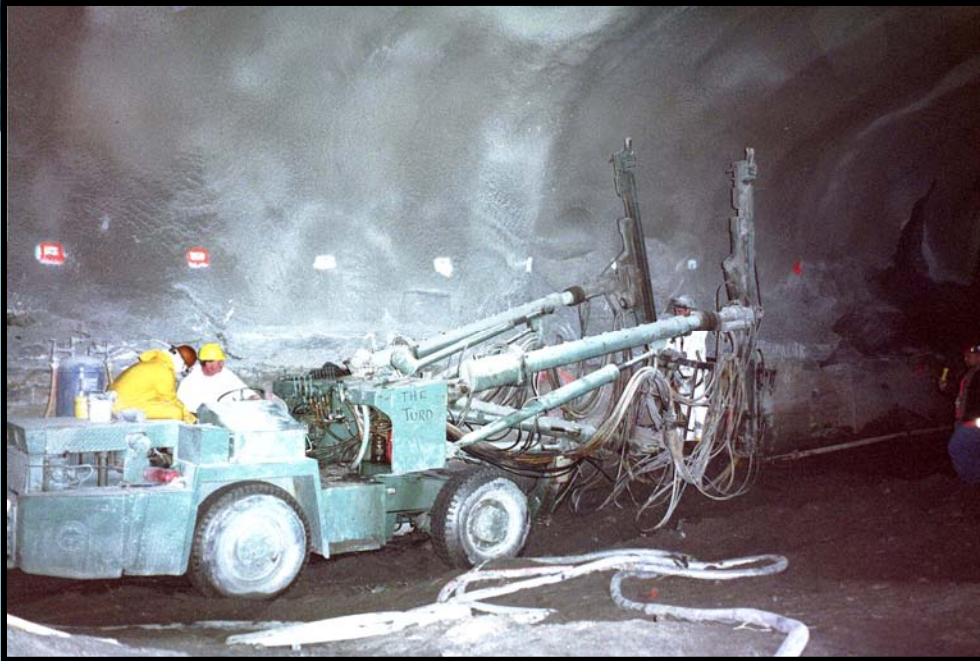
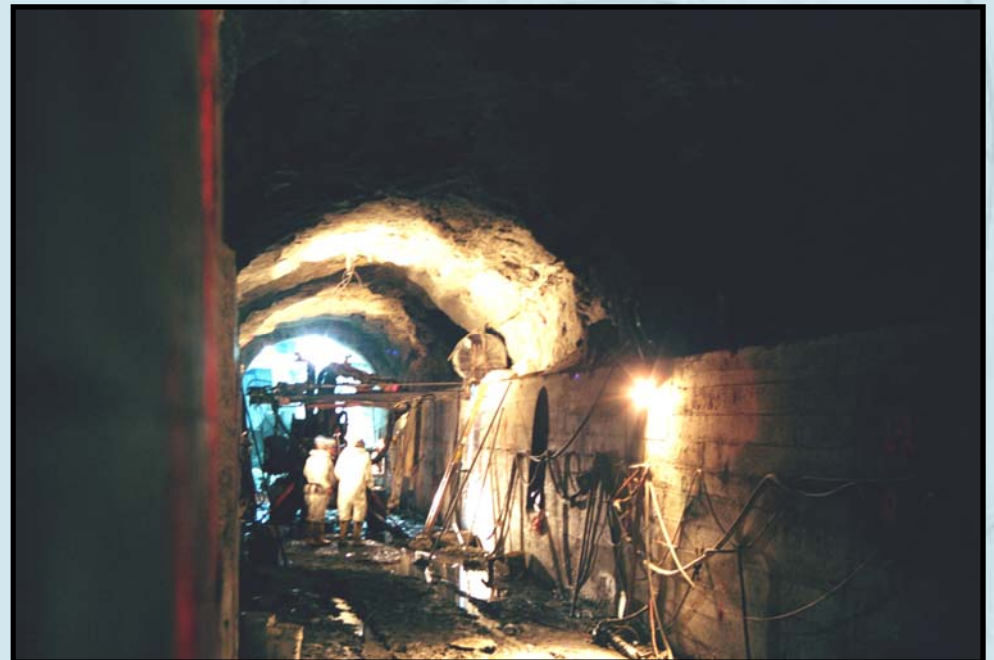
# Rock Bolt Installation

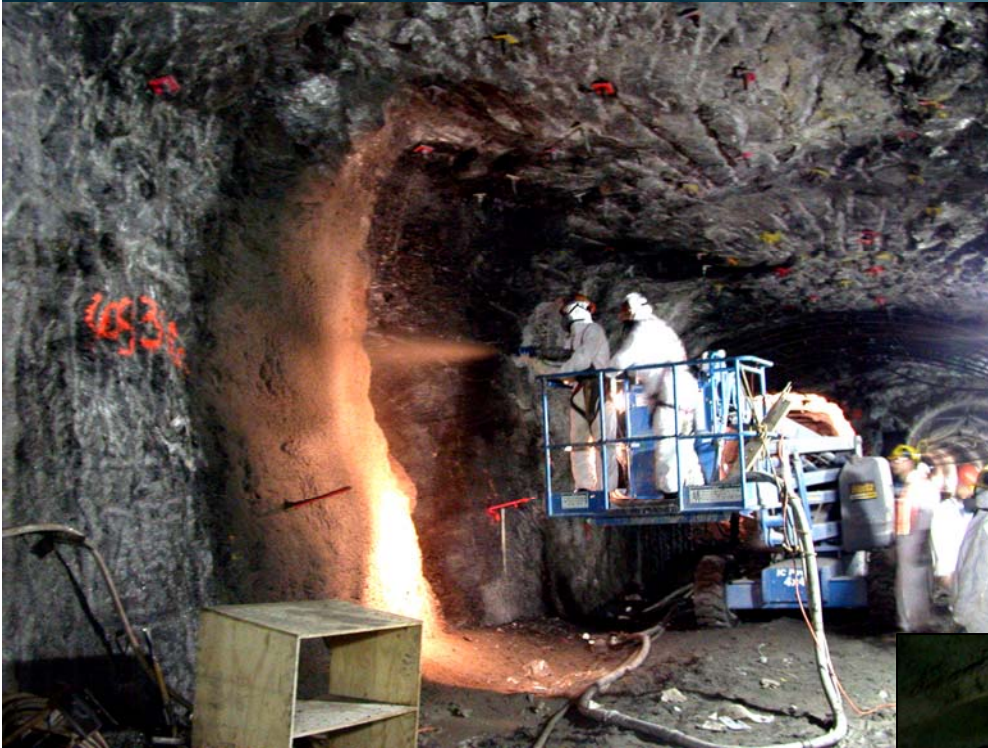
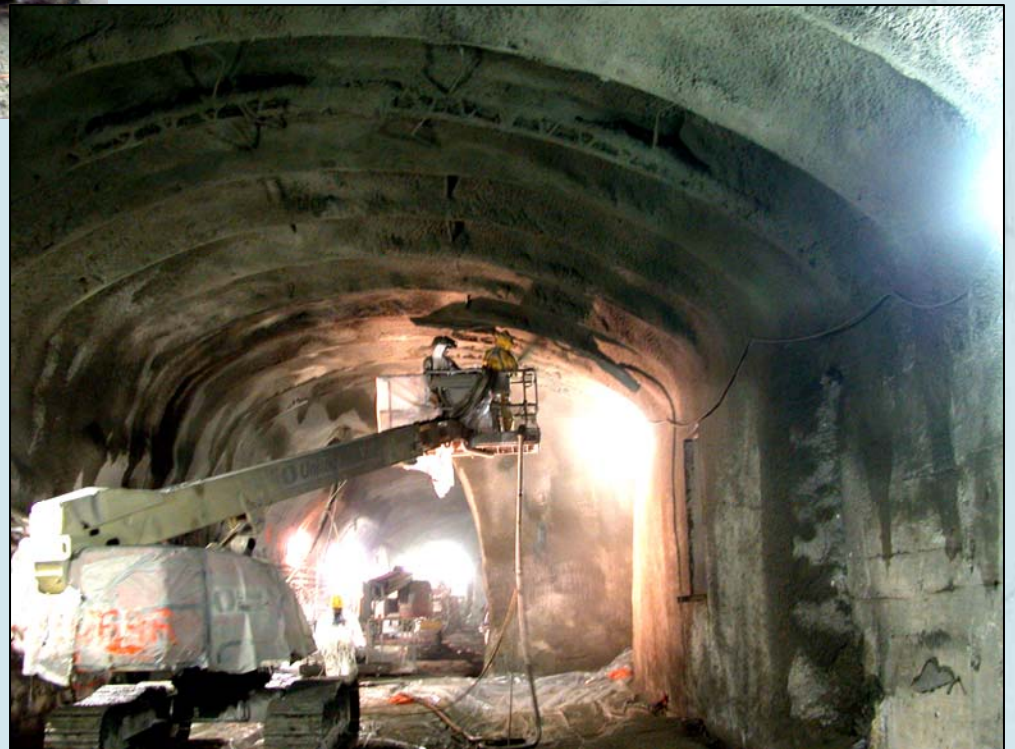
# Shotcrete Application

**Note: The Use of  
Shotcrete as a Final  
Lining saved 6+ months  
on the Project Schedule**

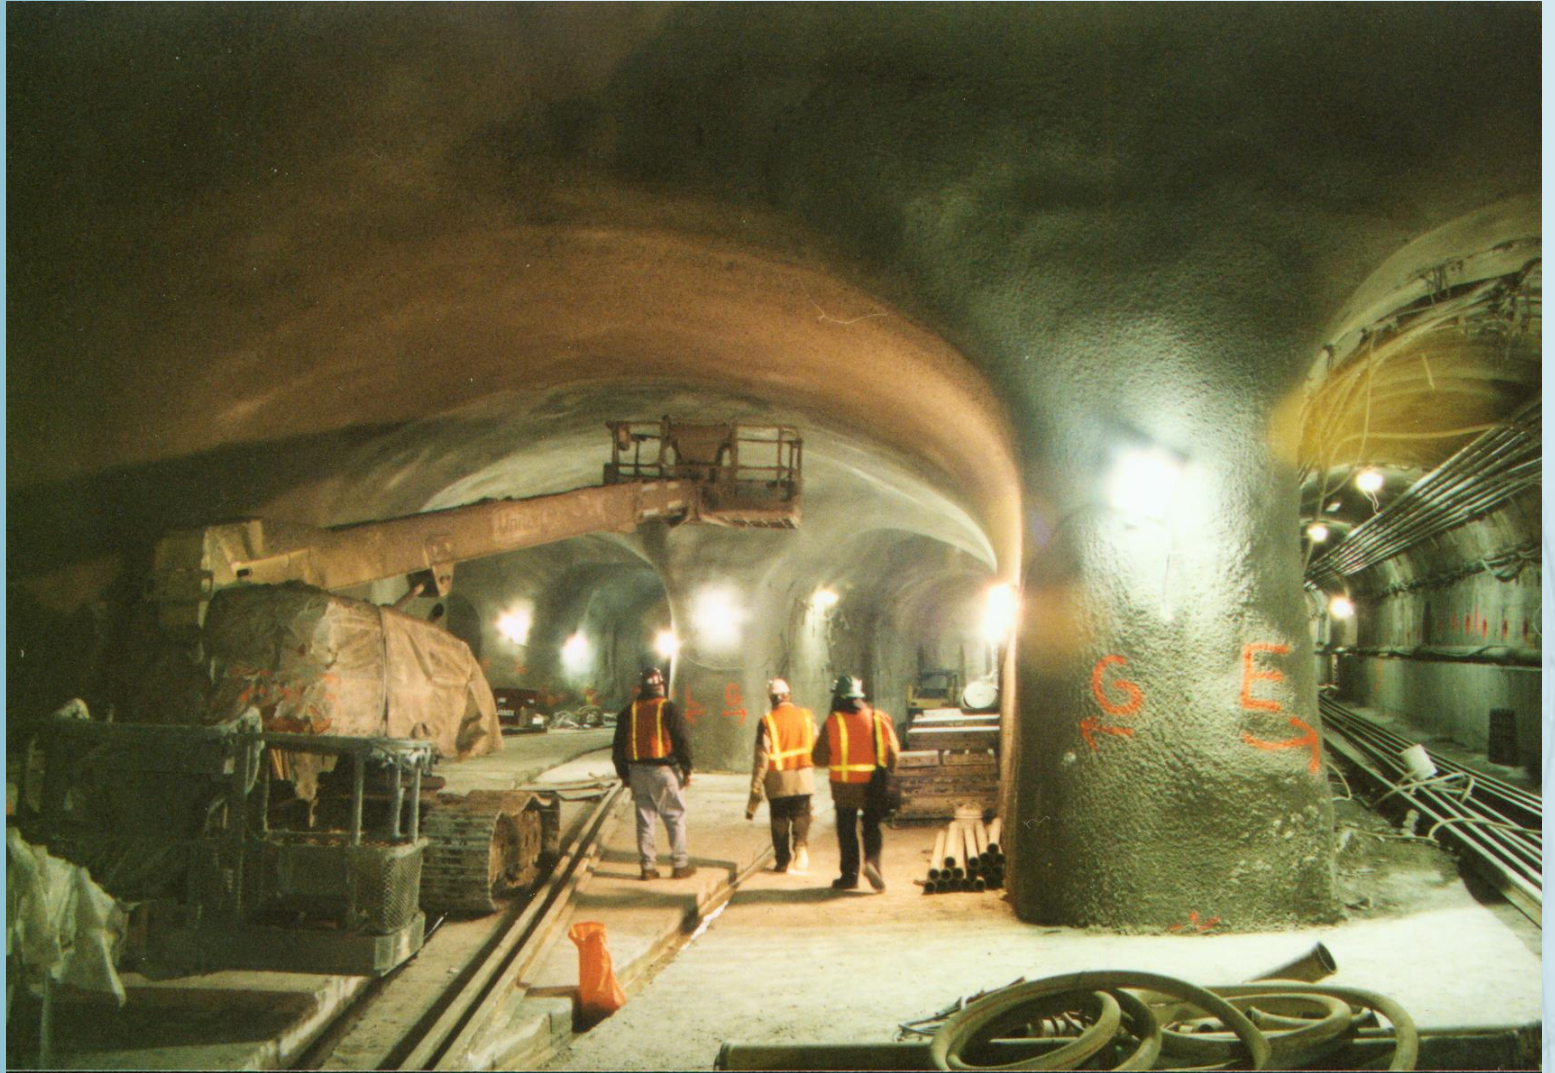
# Final Shotcrete Lining
